Space Shuttle OV-105 Subnominal Bond Investigation

Anna E. Gunn-Golkin
U.S. Air Force Academy, USAFA, CO, 80841

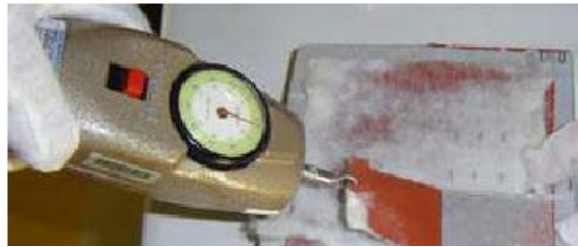
As there is no RTV adhesive peel requirement, this was an engineering evaluation only: a peel value greater than 4 in/lb was considered acceptable. The peels were performed using a chatillion force gauge attached with a hook to pull 1 inch strips of SIP normal to the tile IML.

Figure 6. Peel Test set-up.
